**Flood Control Project Maintenance
Levee Inspections****LMA District Cover Sheet****Spring 2013 Levee Inspection Results****Sutter Maintenance Yard East Levee Sacramento River**

Spring 2013 Levee Inspection Results

Sutter Maintenance Yard East Levee Sacramento River

Levee Inspection Report By Mile - Spring 2013

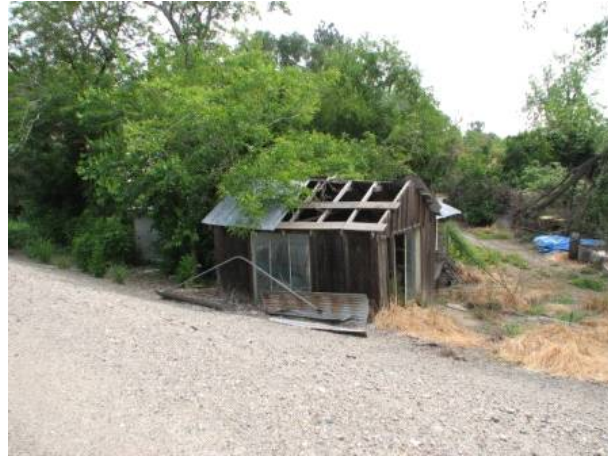
Levee Mile Report Line	4
Start Levee Mile	0.08
End Levee Mile	0.14
Location	Water Side
Category	
Item	Encroachments

View of a old building next to the landside toe.

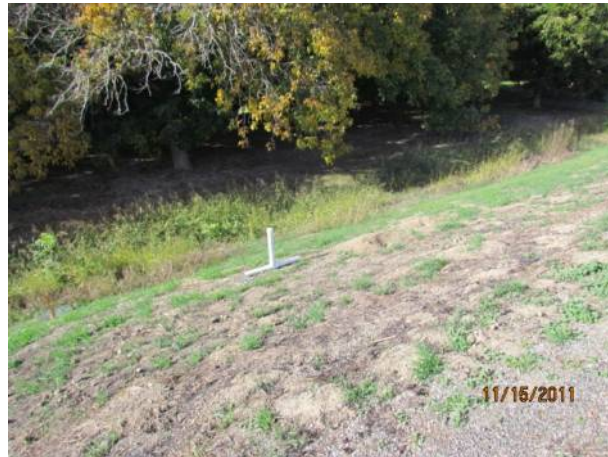
Levee Mile Report Line	7
Start Levee Mile	3.03
End Levee Mile	3.03
Location	Water Side
Category	
Item	Animal Control

View of the rodent holes & bait station.

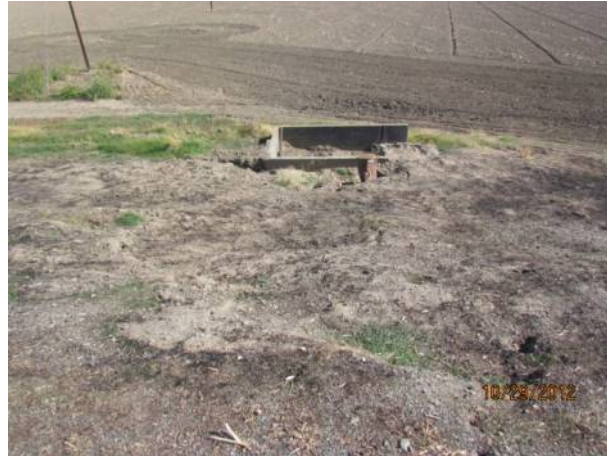
Levee Mile Report Line	9
Start Levee Mile	3.78
End Levee Mile	3.78
Location	Land Side
Category	
Item	Encroachments

View of the subsidence at the levee toe from a hole in the irrigation pipe.

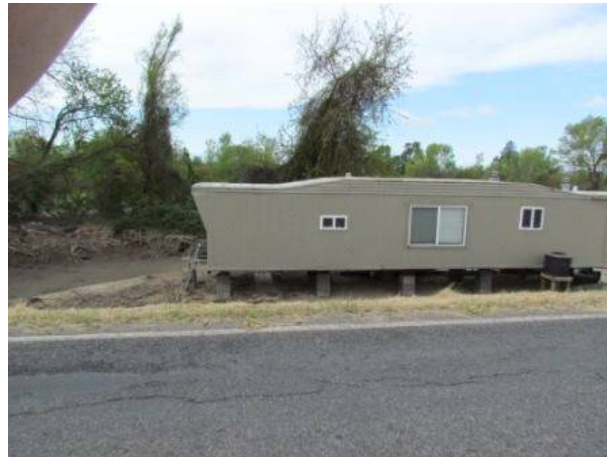
Levee Mile Report Line	10
Start Levee Mile	4.19
End Levee Mile	4.19
Location	Water Side
Category	
Item	Encroachments

View of the trailer next to the W/S toe.

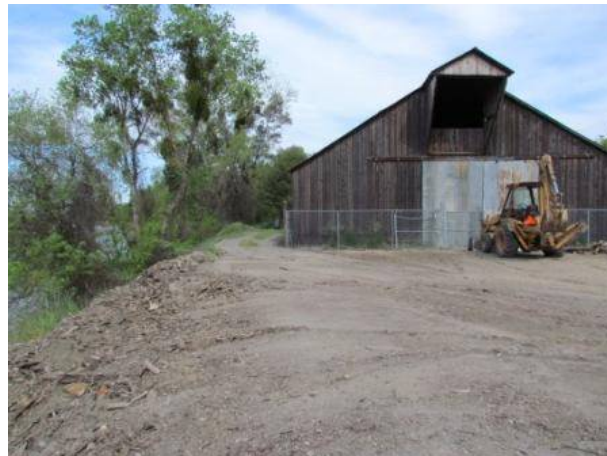
Levee Mile Report Line	11
Start Levee Mile	4.66
End Levee Mile	4.84
Location	Crown
Category	
Item	Encroachments

View of the barn on the large crown of the levee.

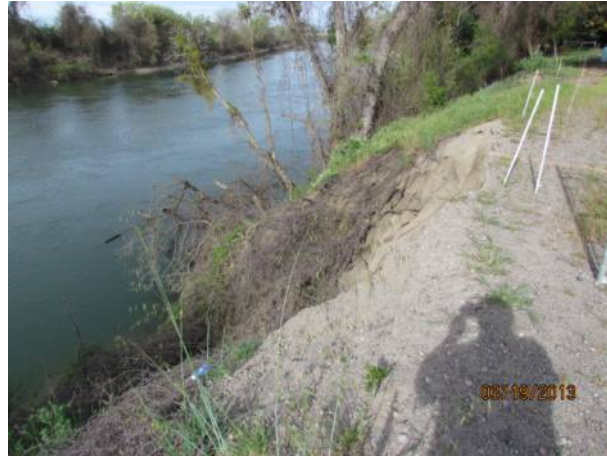
Levee Mile Report Line	12
Start Levee Mile	4.66
End Levee Mile	4.66
Location	Water Side
Category	
Item	Slope Stability

View of the erosion along the waterside slope.

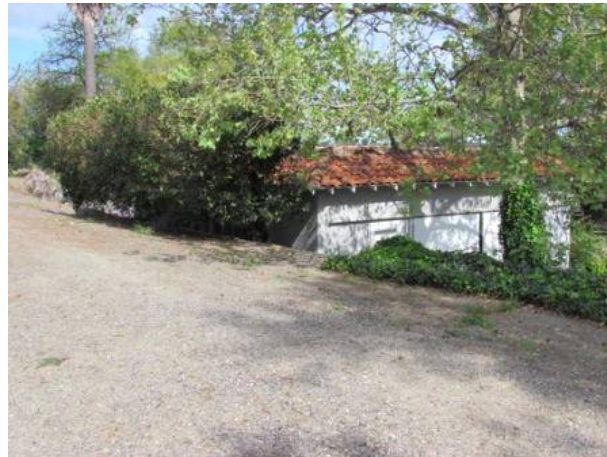
Levee Mile Report Line	13
Start Levee Mile	4.81
End Levee Mile	4.81
Location	Land Side
Category	
Item	Encroachments

View of the building next to the L/S toe.

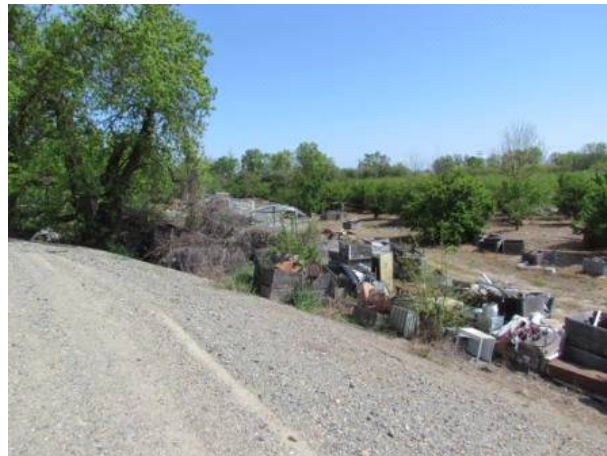
Levee Mile Report Line	17
Start Levee Mile	6.42
End Levee Mile	6.42
Location	Land Side
Category	
Item	Encroachments

View of the material & garbage along the toe.

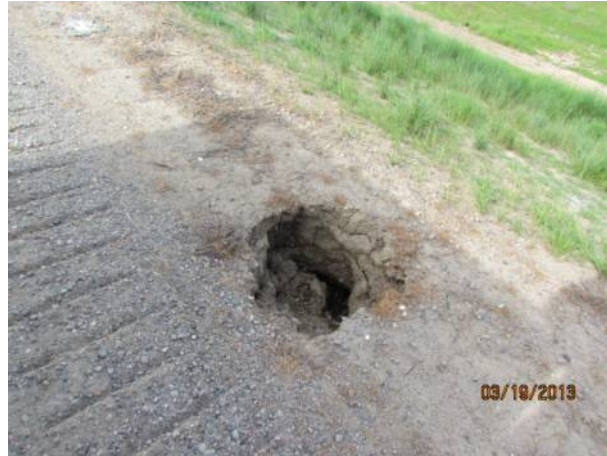
Levee Mile Report Line	18
Start Levee Mile	6.80
End Levee Mile	6.80
Location	Water Side
Category	
Item	Erosion / Bank Caving

Erosion along the waterside crown.

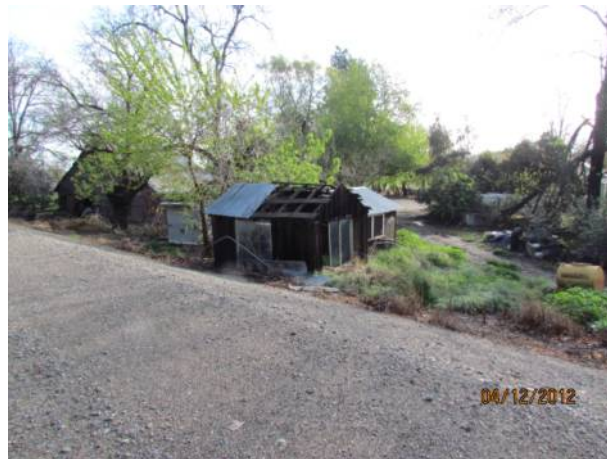
Levee Mile Report Line	19
Start Levee Mile	8.76
End Levee Mile	8.76
Location	Land Side
Category	
Item	Encroachments

View of the building next to the toe of the levee.

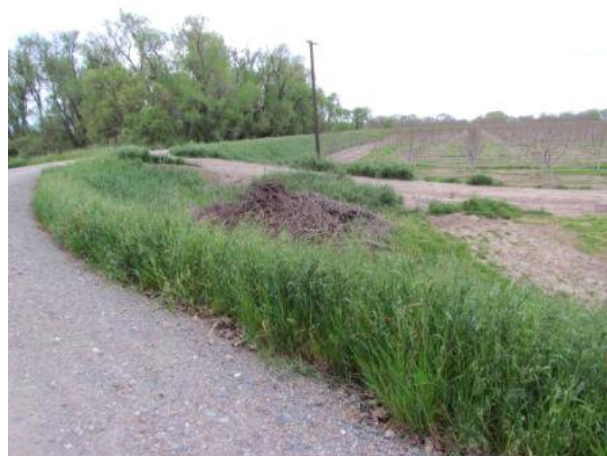
Levee Mile Report Line	20
Start Levee Mile	9.23
End Levee Mile	9.23
Location	Land Side
Category	
Item	Encroachments

View of the prunings along the L/S toe.

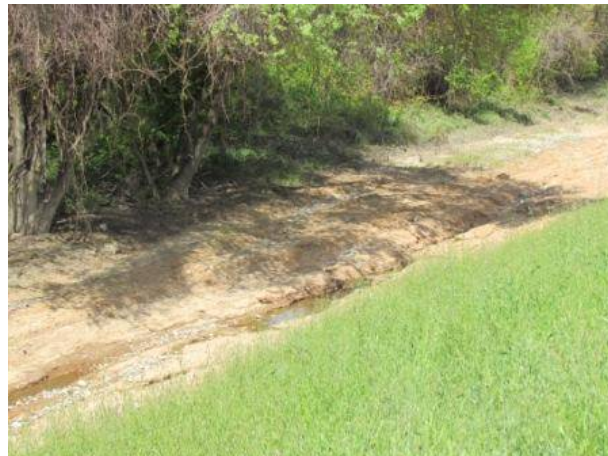
Levee Mile Report Line	28
Start Levee Mile	13.47
End Levee Mile	13.66
Location	Water Side
Category	
Item	Erosion / Bank Caving

LMR No.	Levee Mile		Category	Item	* Location	** Rating	Action/Comment	GPS Latitude/Longitude		Issue No.
	Start	End						Start	End	Photo
28	13.47	13.66		Erosion / Bank Caving	WS	M Ma	E1 : Note and monitor erosion site.	39.307448 ° -122.013037 °	39.310231 ° -122.012912 °	9 Y
DWR ID: DWR_ST0003_01_s_2012_9										
29	14.55	14.55		Encroachments	WS	U En	PI : Pipe	39.322254 ° -122.015985 °	39.322254 ° -122.015985 °	25 Y
DWR ID: DWR_ST0003_01_s_2013_25										
30	16.95	16.95		Encroachments	LS	M En	PR : Prunings	39.347308 ° -122.015264 °	39.347308 ° -122.015264 °	36 Y
DWR ID: DWR_ST0003_01_f_2012_36										
31	17.44	17.44		Encroachments	LS	M En	PR : Prunings	39.351311 ° -122.009409 °	39.351311 ° -122.009409 °	30 Y
DWR ID: DWR_ST0003_01_s_2013_30										
32	18.00	18.08		Encroachments	LS	M Ma	FW : Firewood	39.358956 ° -122.007492 °	39.359565 ° -122.006219 °	10
DWR ID: DWR_ST0003_01_s_2012_10

View of the erosion along the W/S toe.

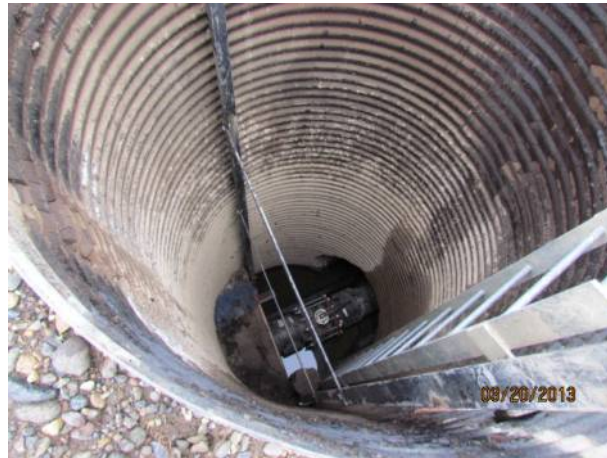
Levee Mile Report Line	29
Start Levee Mile	14.55
End Levee Mile	14.55
Location	Water Side
Category	
Item	Encroachments

View of the unauthorized pipe placed inside the drain pipe.

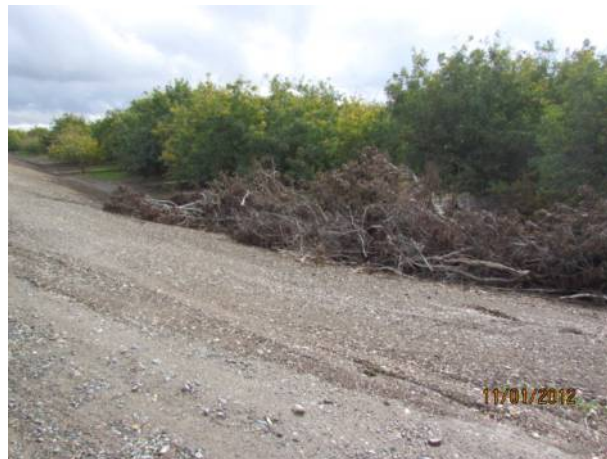
Levee Mile Report Line	30
Start Levee Mile	16.95
End Levee Mile	16.95
Location	Land Side
Category	
Item	Encroachments

View of the brush pile along the landside toe.

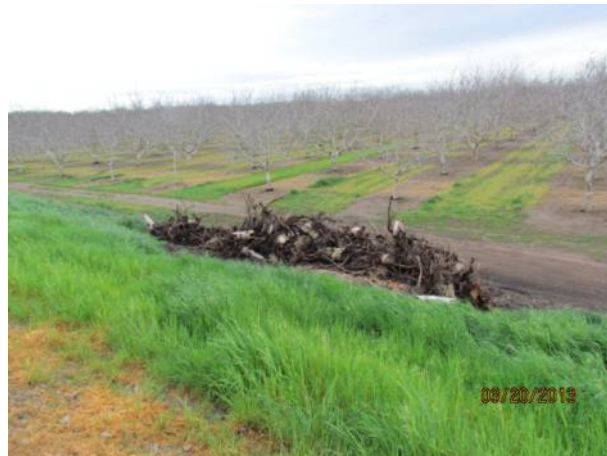
Levee Mile Report Line	31
Start Levee Mile	17.44
End Levee Mile	17.44
Location	Land Side
Category	
Item	Encroachments

View of the walnut orchard stumps along the landside toe.

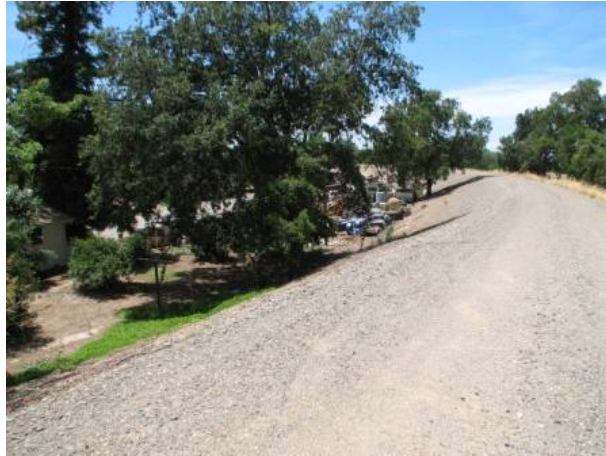
Levee Mile Report Line	33
Start Levee Mile	18.04
End Levee Mile	18.18
Location	Land Side
Category	
Item	Encroachments

33	18.04	18.18		Encroachments	LS	M Ma	EQ : Equipment	39.359188 ° -122.006878 °	39.359980 ° -122.004517 °	16 Y
DWR ID: DWR_ST0003_01_s_2012_16										
34	18.80	18.80		Animal Control	WS	M Ma	A3 : No rodents visible, but rodent burrows visible; need to backfill and compact or grout burrows.	39.364865 ° -121.997788 °	39.364865 ° -121.997788 °	26
DWR ID: DWR_ST0003_01_s_2012_26

View of the equipment and trees next to the landside toe of the levee.

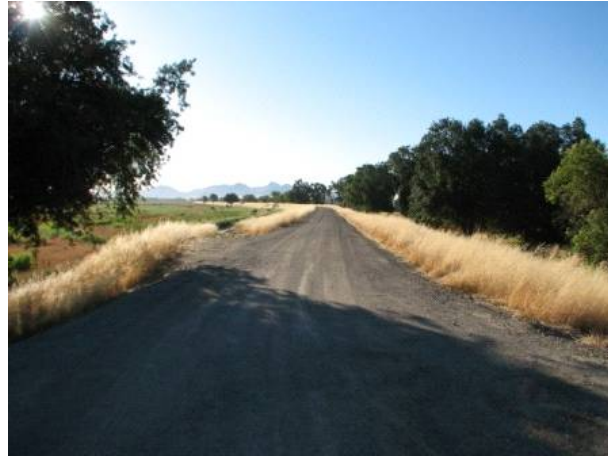
View of the elderberries along the landside toe of the levee.

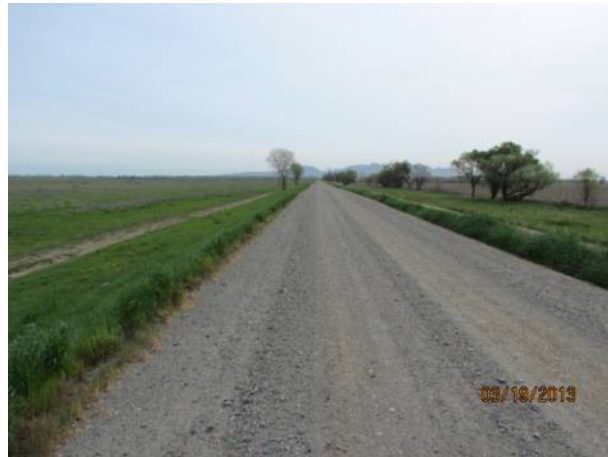
Levee Mile Report Line	2
Start Levee Mile	0.38
End Levee Mile	0.38
Location	Water Side
Category	
Item	Vegetation

View of the native grasses on both slopes.

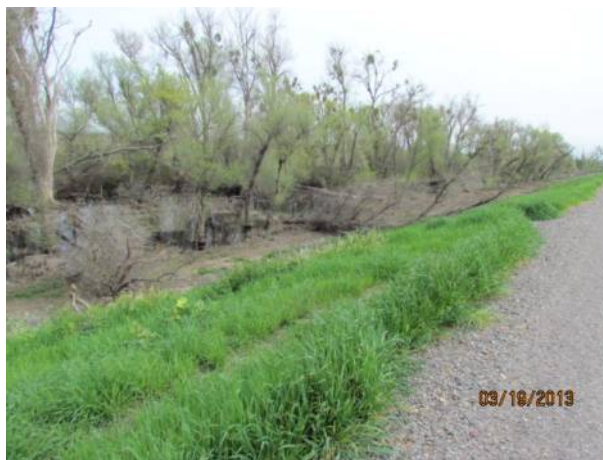
View of the downed willow trees along the landside toe.

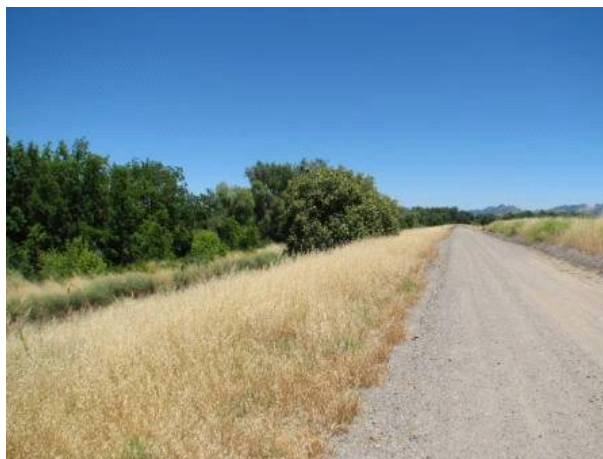
Levee Mile Report Line	2
Start Levee Mile	1.98
End Levee Mile	1.98
Location	Land Side
Category	
Item	Vegetation

View of the elderberries along the landside toe of the levee.

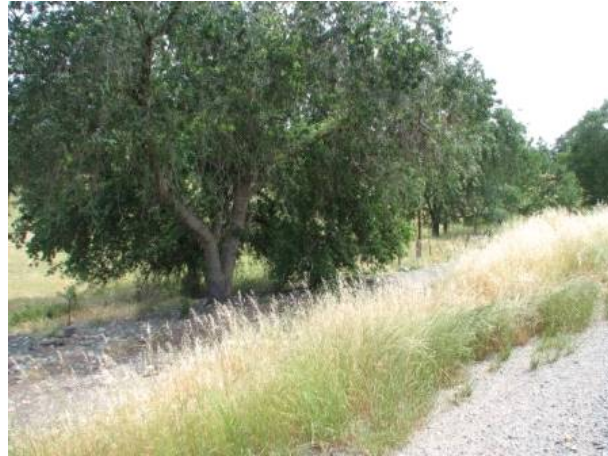
View of an elderberry bush by the waterside toe.

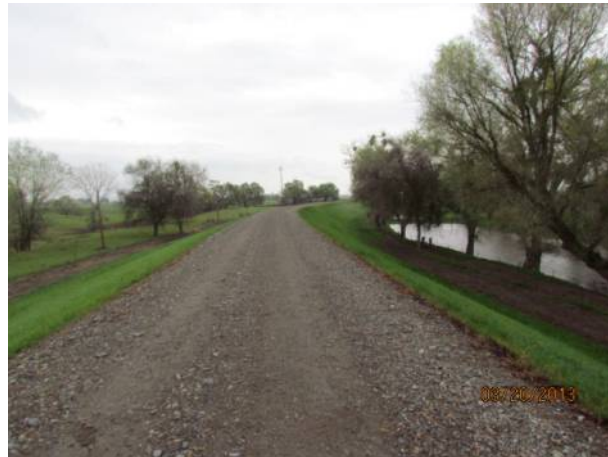
Levee Mile Report Line	2
Start Levee Mile	0.06
End Levee Mile	0.06
Location	Land Side
Category	
Item	Vegetation

View of the native grass on both slopes.

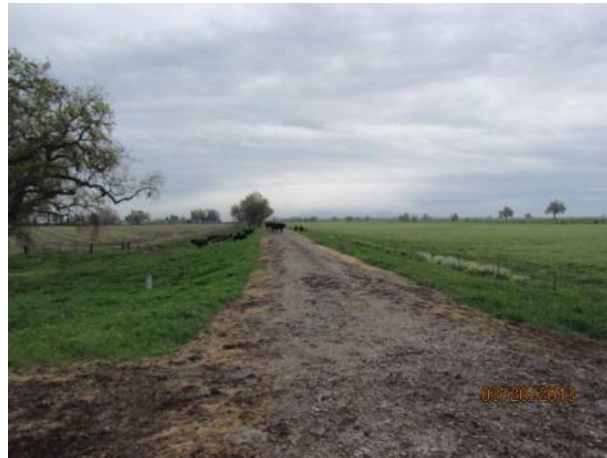
View of the landowners livestock on both slopes.

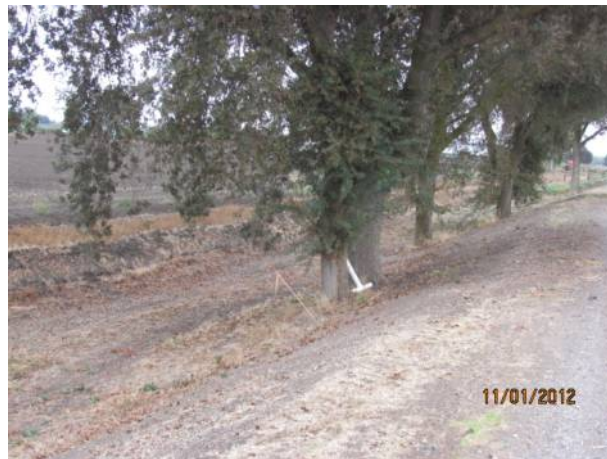
Levee Mile Report Line	2
Start Levee Mile	0.77
End Levee Mile	0.77
Location	Land Side
Category	
Item	Slope Stability

View of the repaired rodent holes and bait station along the landside slope.

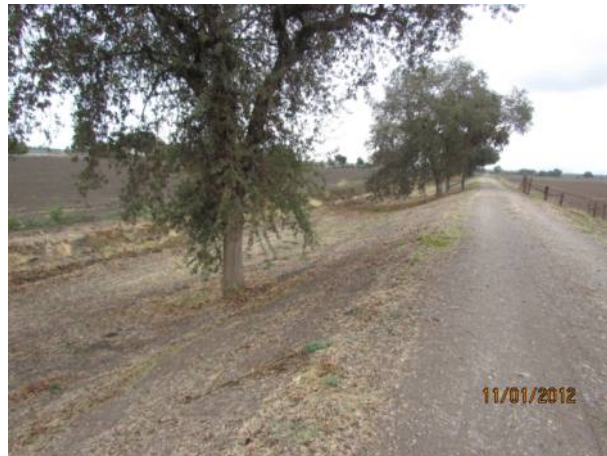
Levee Mile Report Line	3
Start Levee Mile	0.85
End Levee Mile	0.85
Location	Land Side
Category	
Item	Animal Control

View of the repaired rodent holes along the landside slope.

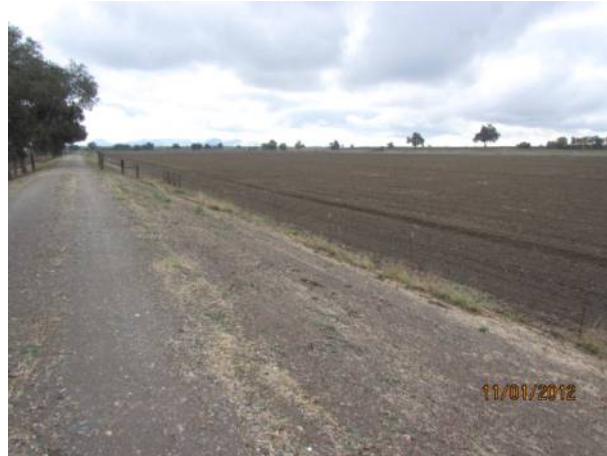
Levee Mile Report Line	4
Start Levee Mile	0.85
End Levee Mile	0.85
Location	Water Side
Category	
Item	Animal Control
View of the repaired rodent holes along the waterside slope.	
rduffey_s_20130225_280.JPG

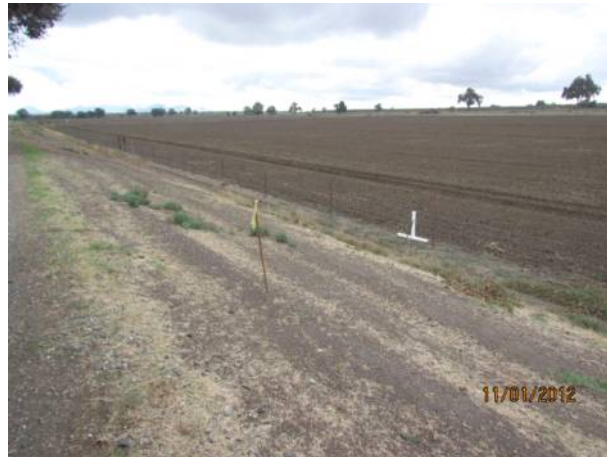
Levee Mile Report Line	5
Start Levee Mile	1.06
End Levee Mile	1.06
Location	Water Side
Category	
Item	Animal Control
View of the repaired rodent holes and bait station along the waterside slope.	
rduffey_s_20130225_281.JPG
